OUTER HYLEBOS 1998 MONITORING REPORT

August 10, 1999

Subject: Final Outer Hylebos Fourth Monitoring Report 1998

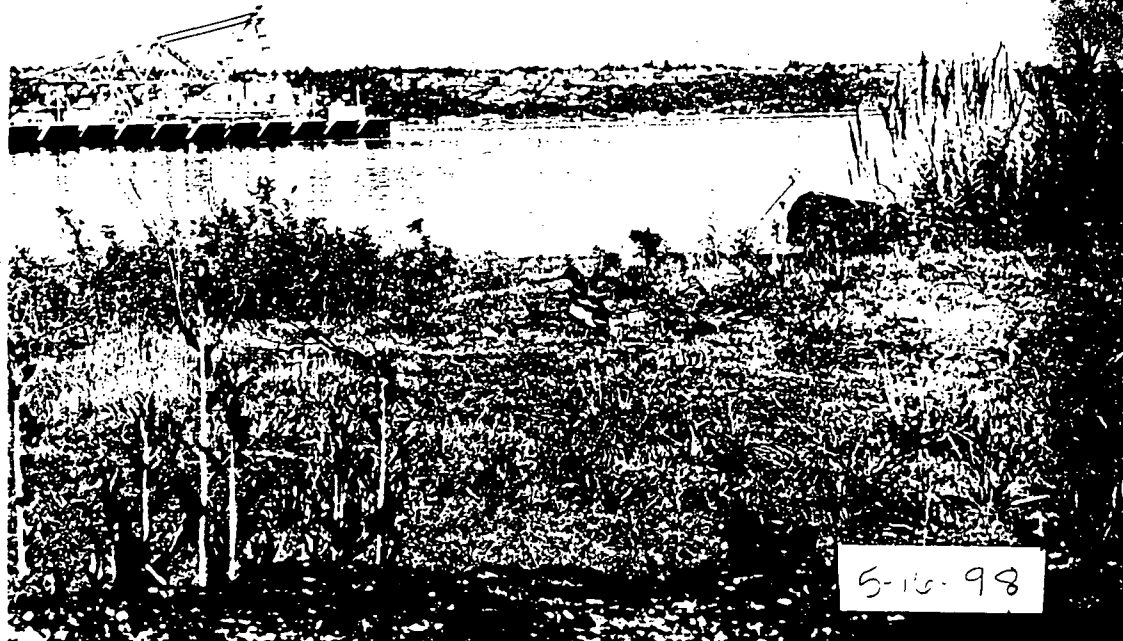
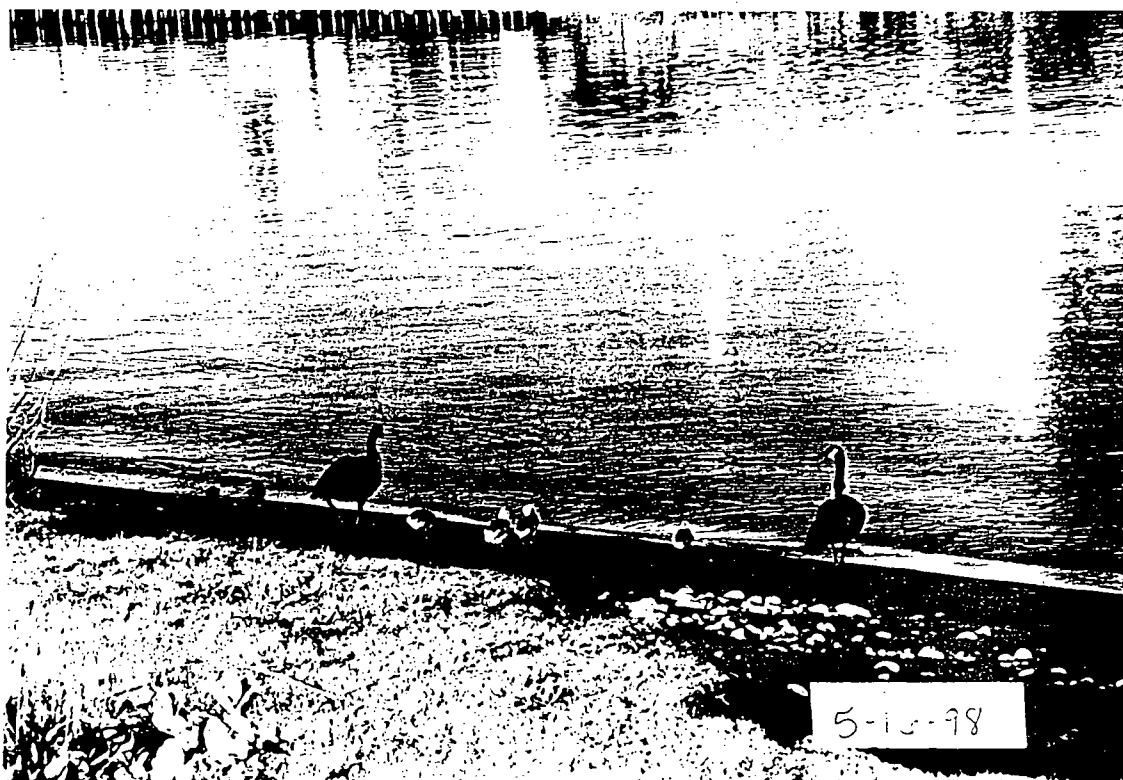
FIGURE 6. SPRING WILDLIFE OBSERVATIONS
OUTER HYLEBOS 4TH MONITORING REPORT - 1998

Wildlife observations for 1998 are similar to those in previous years. The Outer Hylebos site is supporting a large number of bird species year round (Figure 6). This means that the mitigation site is providing adequate food and cover and the species observed have adapted to the created habitat. Although bird species were abundant, the large numbers of Canada geese (*B. canadensis*) that were previously noted have decreased since 1996. Wildlife species observed during the 1998 monitoring are included in Table 13 (page 19). As noted in Table 5 the number of bird species noted during the winter monitoring event was low. This was believed to be a result of an excessive amount of boat activity in the area. The boat activity during the winter monitoring event was significantly greater during the winter event than during any other of the 1998 monitoring events.
